ENVIRONMENTALLY FRIENDLY COASTAL PROTECTION BASED ON VERTICAL DRAINS

Poul Jakobsen and Claus Brøgger^{1 2}

A Field test over 11 km with the SIC vertical drain system was carried out in January 2005 up till January 2008 and placed at Skodbjerg at the Danish west coast. Already after 6 month has the vertical drain system stabilized the beach in an equilibrium profile. The average beach level from the dune foot and 100 m. wide was after 3 years up to 157 cm higher in the drained areas in relation to the reference area 2. The erosion was stopped in the drained area's, and the sand drift increased to the dune system over the next 3 years. The sand drift from the beach to the dune system is calculated to 69 – 76 cubic meters pr. meter along the coastline in the drained areas over 3 years.

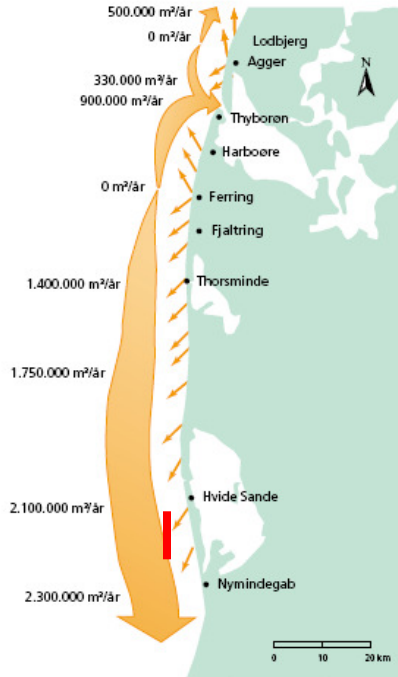
Fig. 1

The Danish west coast is a high erosion area as we see in fig 1. The erosion at 110 km is total 4.030.000 cubic meters yearly.

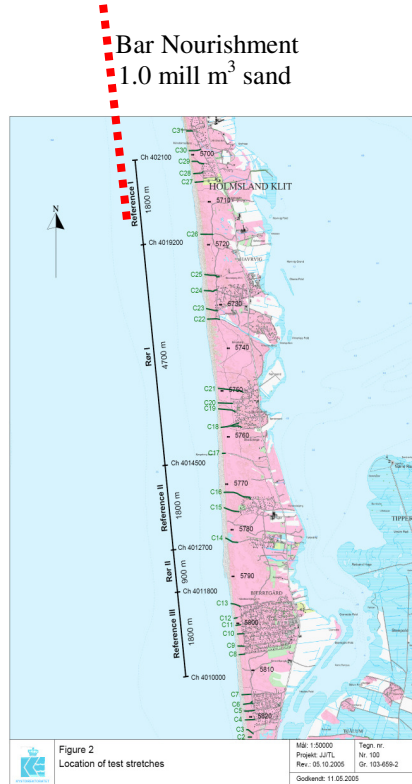
Fig. 2

The test site is placed 5 km south of Hvide Sande Port in a lee side erosion area. The Coastal Authority has tried to disturb the project with an unplanned Bar nourishment at 1,0 mill. m³ sand, but the sand is still lying in the area, where the sand was placed. There is a well known competition situation between SIC and KDI. 190.000 m³ sand are placed off shore in ref. 1.

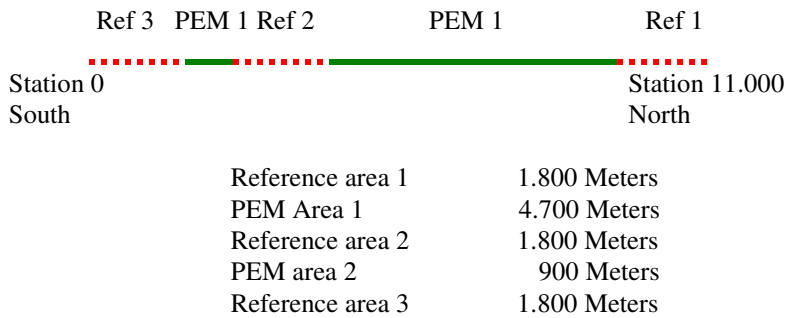
Reference area 1	1.800 Meters
PEM Area 1	4.700 Meters
Reference area 2	1.800 Meters
PEM area 2	900 Meters
Reference area 3	1.800 Meters

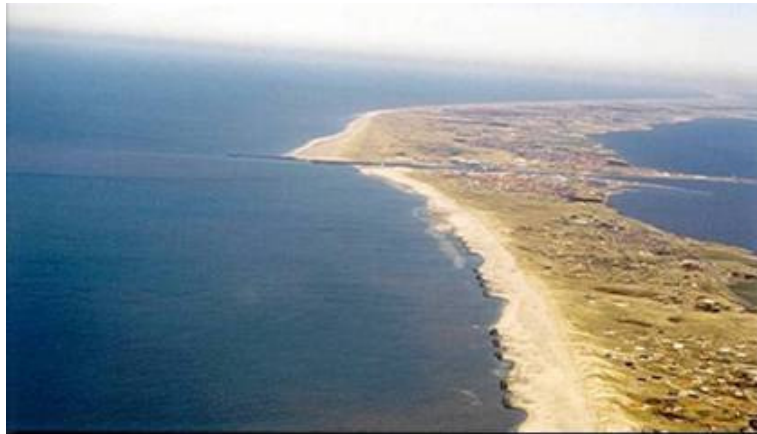
Fig. 3

A groin of rocks is placed 450 meters out in the sea north of the channel into Hvide Sande Port.

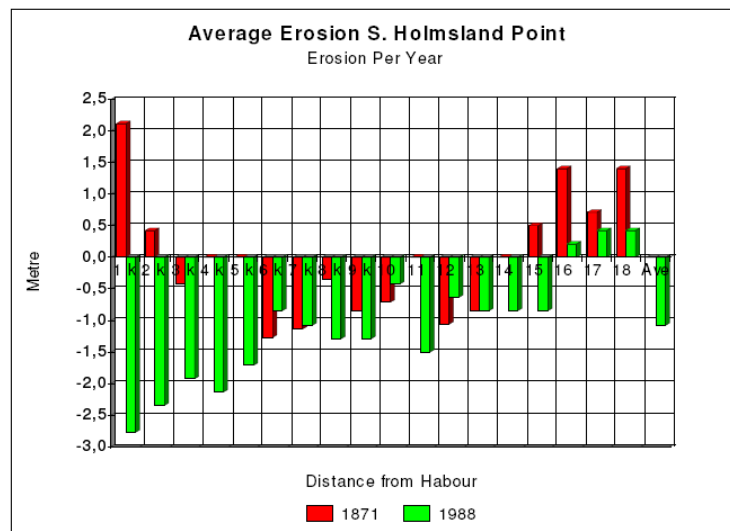
Fig. 4

As we see in fig. 4 the groin generates leeside erosion south of Hvide Sande Port. The values are not true because the groin is first placed in 1962 and the light grey shows the development from 1871 – 1988.

The most interesting thing is we have accumulation 16 km south from the port over the last 200 years. This area is inside in reference area 3 in the project.

We see in fig. 16 the dune foot move towards the shoreline in the drained areas, and big erosion in ref. 1 b and ref 2. Ref 3 is an accumulation area over the last 200 years as we saw in Fig. 4. The average erosion in the dune foot in reference area 2 is 15,7 meters over 3 years. We think we would have seen the same situation in ref. 1, if this area not was disturbed with bar nourishment from KDI.

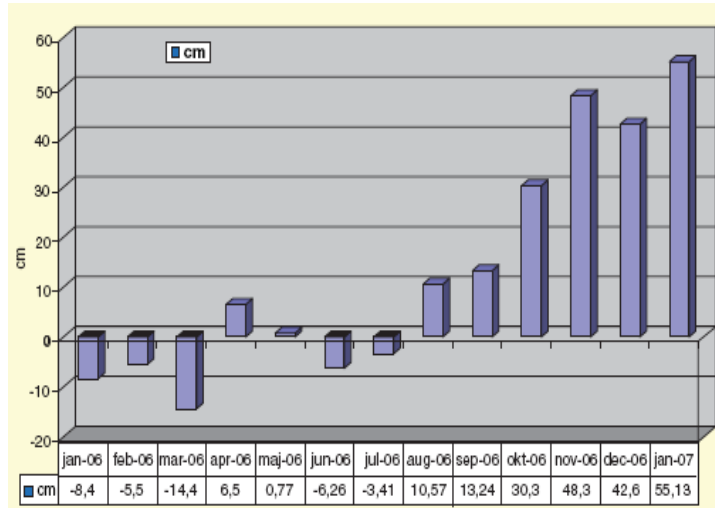
Fig. 5

The sea level was very high at the Danish west coast in the winter time 2006/07. The average sea level was 54 cm over DVR 90 in the period from 20 November 2006 to 20 January 2007.

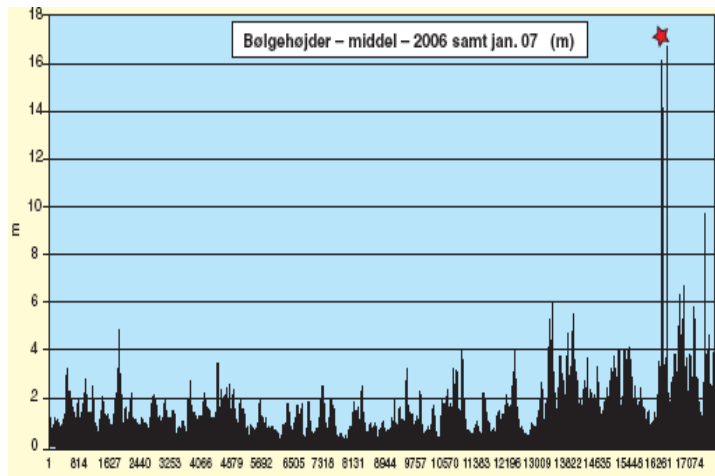
Fig 6 shows the wave height in 2006 and January 2007, where we have 5 heavy storms at the Danish west coast and 4 storms from 1. - 20. January 2007.

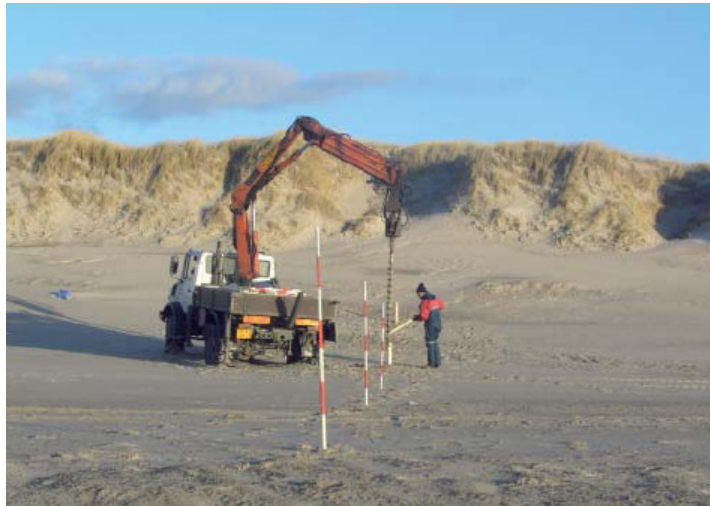
Fig. 7

The PEM modules are placed in a matrix along the coast line, with a distance at 100 meters between the rows and 10 meters in the cross.

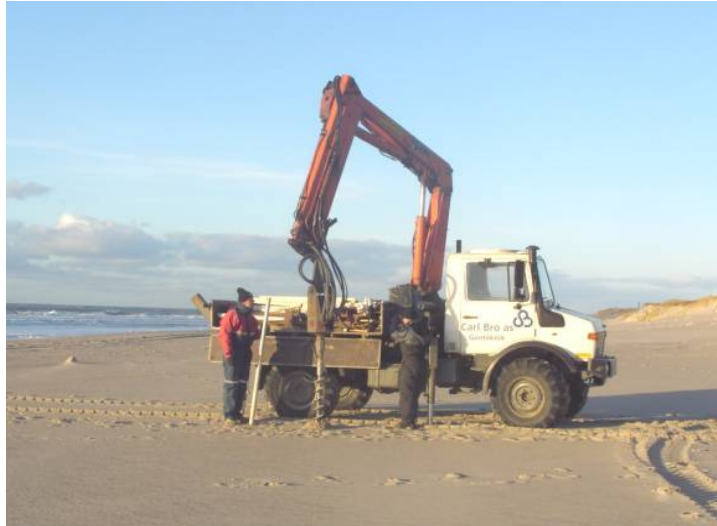
Fig. 8

The PEM modules are 175 cm long and are submerged 25 cm under the beach surface and are normally not visible at the beach. There are max 11 PEM modules in each row, because we don't like the beach wider than 100 meters.

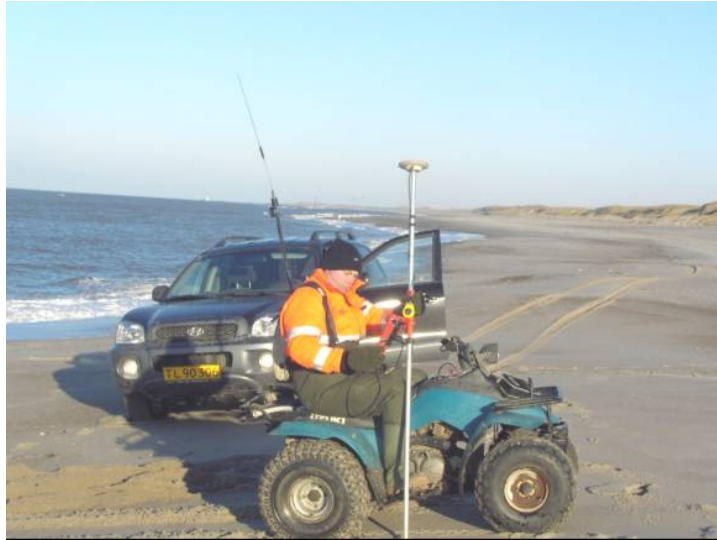
Fig. 9

The survey program is quarterly with 13 surveys over 3 years. There is 100 meters between the survey lines at the beach and the tolerance is below 2 cm. The survey and data processing are done by Carl Bro A/S Denmark.

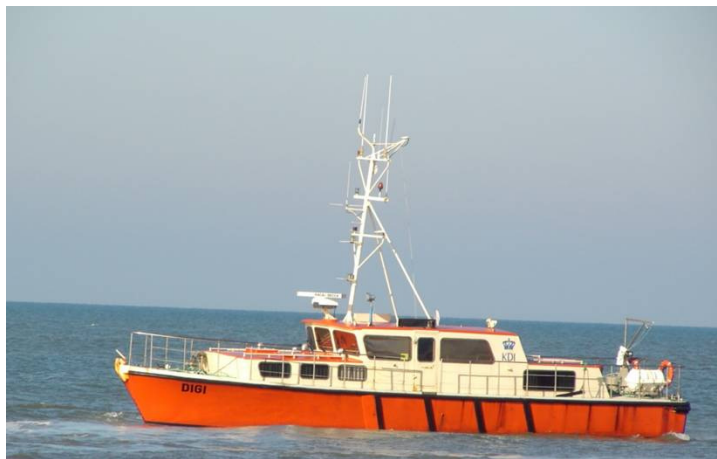
Fig 10

In the first year the sea survey was quarterly and half yearly in year 2 and 3 in the project period. The distance between the survey lines along the coast line is 200 meters and 600 meters out in the sea.

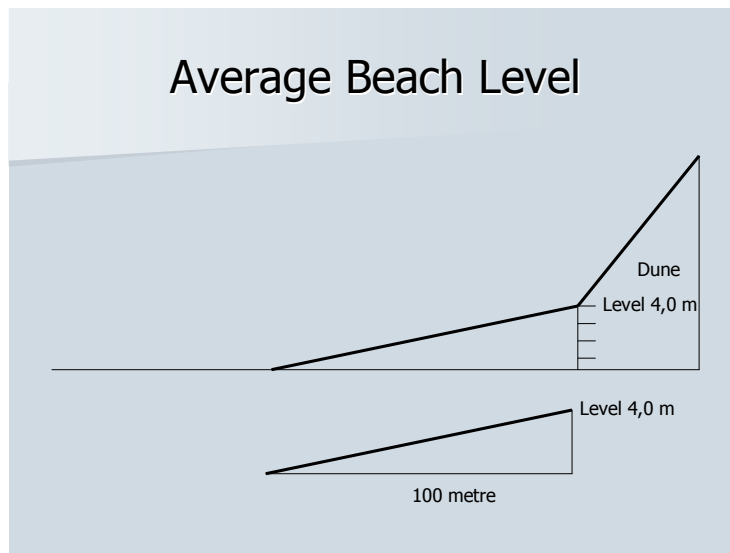
Fig 12

The evaluation is based at the dunes, average beach level (ABL) 100 meters wide from the dune foot (Fig. 12), and offshore 1 and 2 both 300 meters wide.

The ABL calculations are locked to the dune foot level + 4 m January 2005.

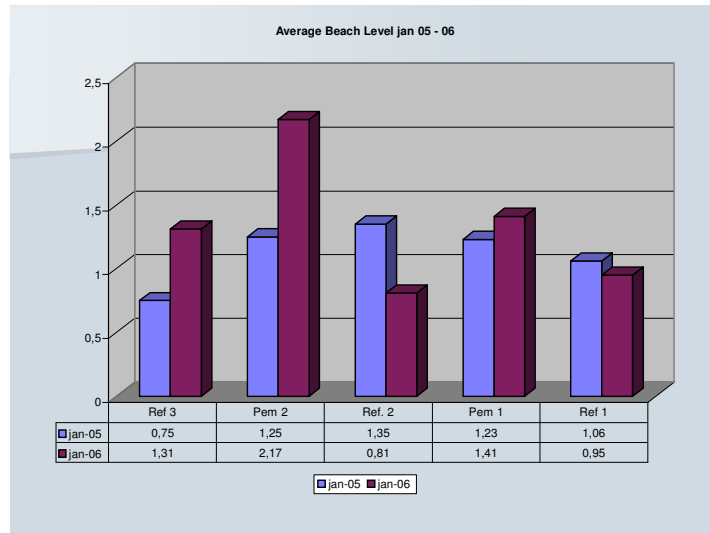
Fig. 13 shows the average beach level by the project start January 2005 and January 2006 after the first year. Ref. 2 was the strongest area with ABL 1,35 m at project start.

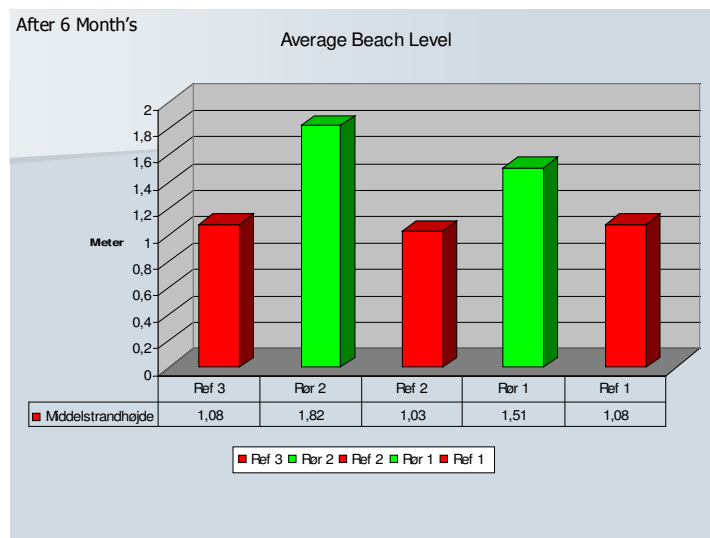
Fig. 14

Already after the first 6 month the results of the vertical drains was significant in relation to the reference areas.

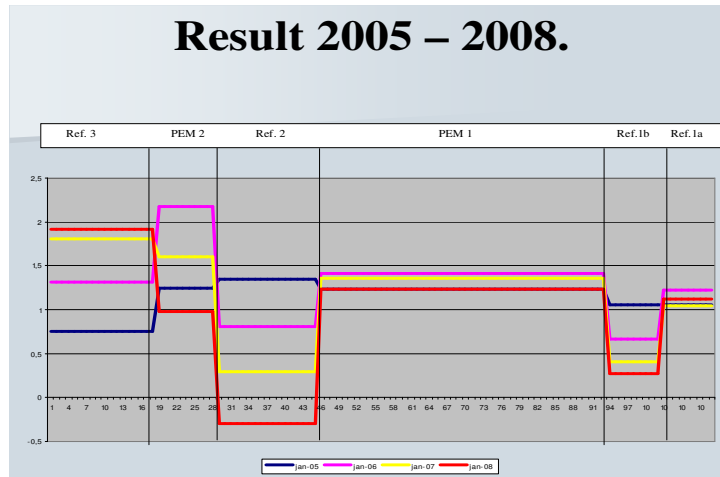
Fig 15

We see in fig. 15, there is a very significant and clear result after 3 years. The average beach level in PEM 1 is 157 cm higher in relation to ref. 2. The average beach level in PEM 2 is 137 cm higher in relation to ref 2.

We register during the first year that ref. 1 was disturbed with Bar Nourishment done of the Coastal Authorities in Denmark.(KDI)

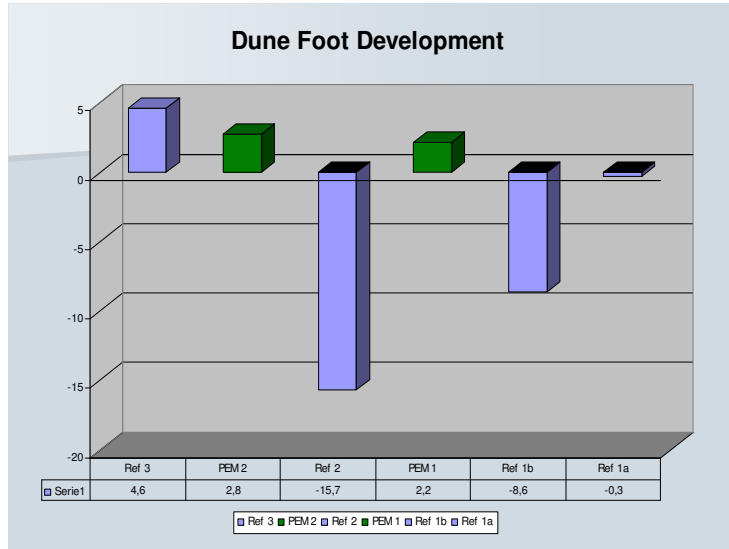
Fig. 17

After 3 years we see in fig 17 the dune foot moves towards the shoreline in the drained areas and ref. 3, where we have leeside accumulation. In contrast we have big sea erosion in ref 2 and 1 b.

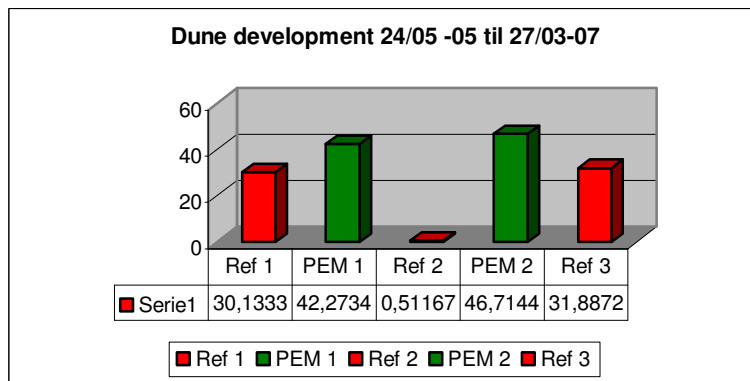
Fig. 18

We have a laser scan survey with airplane, as cover the area from the dune foot level 4 and 300 meters inside in the hinterland over 22 month. The result is very significant. The sand drift to the hinterland is 50 % higher from the drained areas in relation to ref. 1 and 3. There is no accumulation in ref. 2, because we have big sea erosion in the dune front with a negative ABL at - 29 cm at the beach.

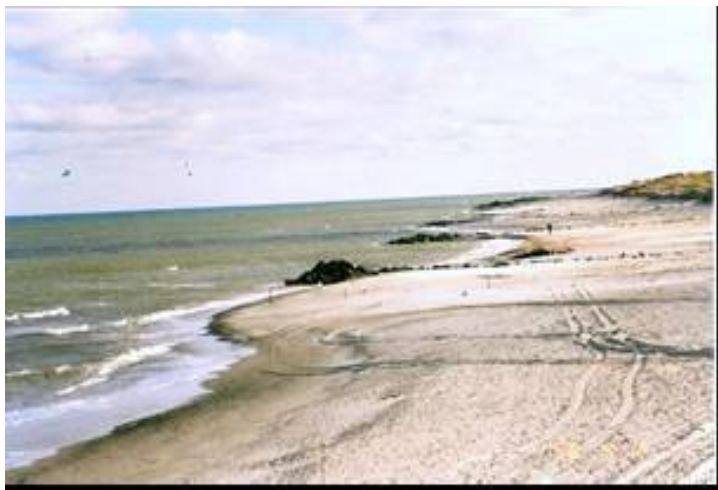
Fig 20

One row with vertical drain tubes Fig. 20 generates here a sand groin by Old Skagen in 1999.

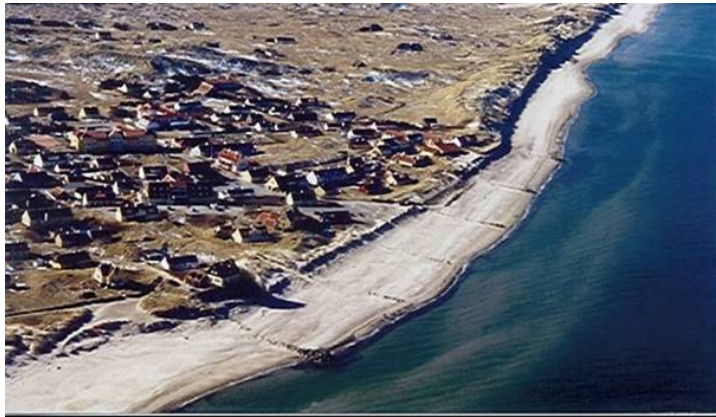
Fig. 21

Fig 21 is an Aerial photo from year 2000 from old Skagen with drain tubes between the groins. We see clearly the sand groins between the old groins of stones as lay inside at the beach.

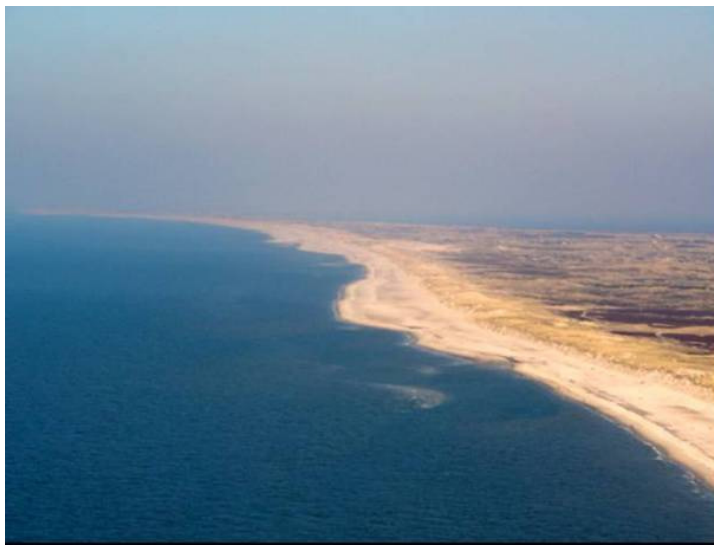
Fig. 22

In fig. 22 we see the effect of the drain tubes by Skodbjerge in the PEM area 2 after 6 month in July 2005.
